Construction Innovation Report Hydro-Demolition

B-4858 Deck Rehabilitation

Location: Bridge over Roanoke, Middle and Cashie River on NC 45

INNOVATION REPORT

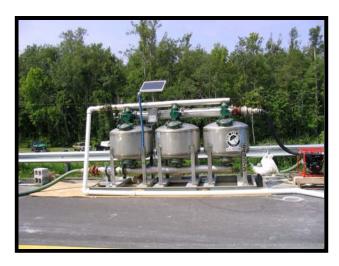
A series of sand filters are located between the first and second tanks in the water purification process.

Water containment was one of the main hvdro-demolition concerns with the process. Before any work could begin, all deck drains were plugged and joints sealed in a manner that adequately contained all of the water. Water was drawn from the river, purified to a neutral pH of seven, pumped to the robot unit for use in hydro-demolition, recycled on site through the purification system and then re-pumped to the robot unit. The purification plant consisted of settlement tank, a sand filter and an aeration tank. In the aeration tank, CO₂ is added to correct the pH level prior to reuse.

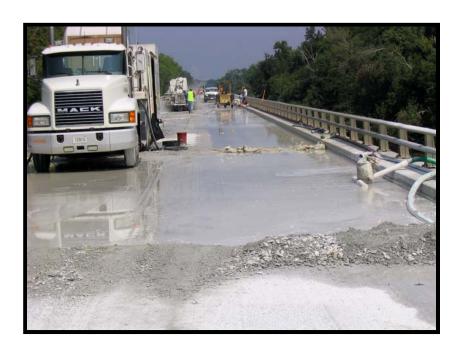
Bridge deck after hydro-demolition. NCDOT inspectors marked areas of unsound concrete for additional surface treatment.
